# Manhole Inspection Summary

Manhole # S09SS\_003MH

Insp Date: **7/20/07 8:27 AM**

**Location** Address: **3304 FAIRVIEW AVE**

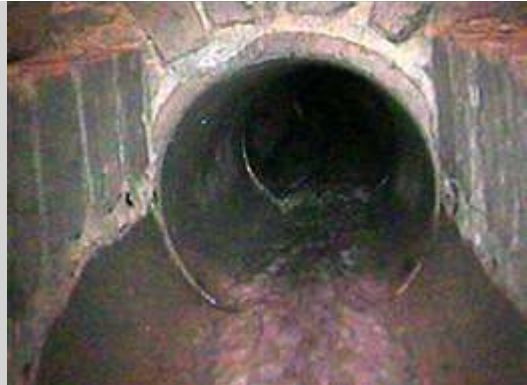
12 O'Clock Outflow

8 in. Circular Gravity Sewer  
Pipe Out @ 12 O'Clock

Invert Depth: **9.58** (ft.) Flow Characteristics: **Slow**

Deposits: ☒ None ☐ Mud ☐ Sludge ☐ Debris ☐ Grease

Infiltration: **None** Pipe Seal Cond: **Sound**

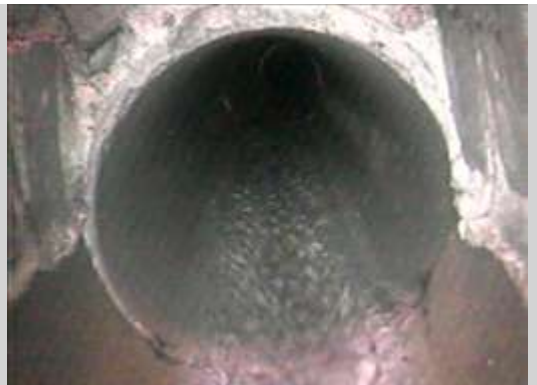
6 O'Clock Inflow

8 in. Circular Gravity Sewer  
Pipe In @ 6 O'Clock

Invert Depth: **9.56** (ft.) Flow Characteristics: **Slow**

Deposits: ☒ None ☐ Mud ☐ Sludge ☐ Debris ☐ Grease

Infiltration: **None** Pipe Seal Cond: **Sound**
